GROUP Campaign	MODEL 2001-2004MY Optima (MS)
NUMBER SC 075	DATE June 2009

SAFETY RECALL CAMPAIGN TECHNICAL SERVICE BULLETIN

REPAIR/REPLACEMENT OF SUBFRAME

This bulletin provides information related to a service campaign for the inspection and related repair, or replacement, if necessary, of the subframe due to corrosion in 2001-2004 Kia Optima vehicles produced from $10/6/2000 \sim 11/19/2003$, that are currently registered in the states where heavy amounts of road salt is used. This condition is typically related to a lack of regular cleaning of the vehicle underbody as outlined in the "Underbody Maintenance" section of the vehicle's owner's manual. In rare cases, the corrosion may be sufficient to warrant a replacement of the subframe.

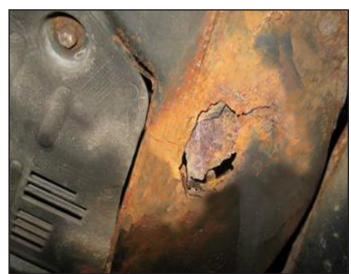
- 2. Inspect the entire subframe assembly for any external signs of severe corrosion/ perforation.
 - a) If any perforation or open cavity is found in the subframe, do not continue repairing. Replace the subframe according to TSB GEN 026. If no signs of perforation or severe corrosion are found, continue to step (b).
 - b) Using a hammer, lightly tap the entire subframe in several areas to check for any material which may be nearing the perforation stage. If the hammer opens up a cavity in the subframe, replace the subframe according to TSB GEN 026.

Make sure to inspect for any corrosion cavity throughout the subframe, including the sides.

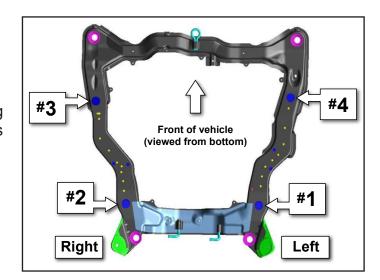
1. In preparation for the drilling of the 40 mm hole-saw cuts for the front / rear subframe sites, the following identification procedure must be utilized to ensure the proper drilling location. The 40 mm hole-saw site locations will be numbered as follows: (1-4) / (Large Blue Holes).

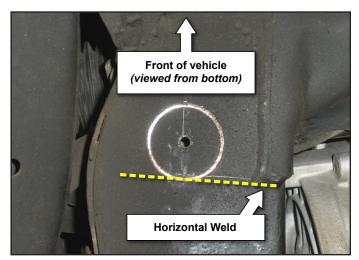
Located on the left-rear of the subframe is drilling site location (One) 1. Using a straight edge ruler, scribe or draw a seventy (70) mm line from the end of the horizontal weld (dashed line).

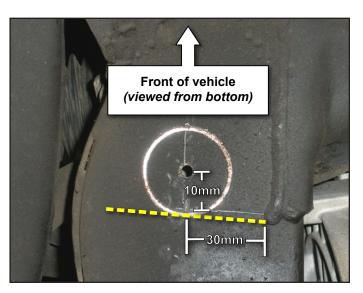
Referencing the dashed line, measure thirty (30) mm from the outer horizontal weld (dashed line) and mark this location. From this new reference mark, measure ten (10) mm forward from this position and mark this location as the center point of the drilling. Drill this location using the forty (40) mm hole-saw (Drill speed recommendation: 380 ~ 470 rpm).

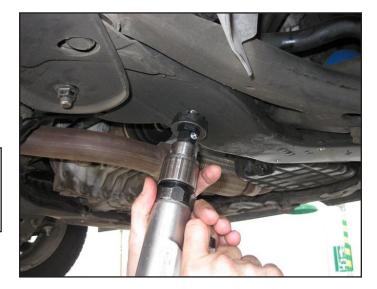
4. Repeat this same procedure (Step 4 & 5) for location Two (2) drill site on the right-rear side of the subframe. Drill this location using the 40 mm hole-saw (Drill speed recommendation: 380 ~ 470 rpm).

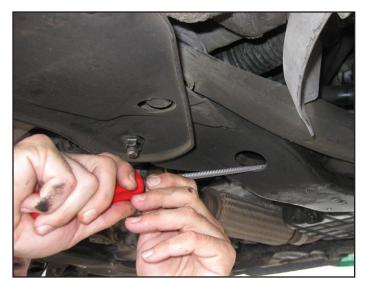
5. Debur the holes on both sides in several areas around the edges of the 40 mm hole so that an accurate judgment of the subframe material thickness can be made.

Failure to perform this deburring step may cause a false "pass" on the subframe condition in the following step.

If the metal burrs are left around the hole, they may block the thickness gauge and indicate that the subframe is thicker than it actually is.

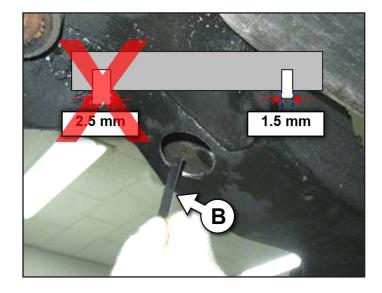
6. Referencing the 1.5 mm side (smallest width) of the thickness gauge, attempt to slide the thickness gauge over the edge of the hole in several different locations on both left/right rear inspection sites.

Ensure that the 1.5mm gauge (smallest width) is used for this test of subframe thickness. Failure to use the correct (1.5mm) gauge will result in unnecessary replacement of subframe.

- a) If the thickness gauge (B) is able to pass over the subframe material, it has failed the 1.5 mm minimum thickness test. Replace the subframe according to TSB GEN 026.
- b) If the gauge will not pass over the subframe material, the corrosion preventive treatment can be performed. Proceed to the next step.
- 7a. In preparation for drilling the 40 mm hole-saw site three (3) in the right front, the following method must be used to insure proper drilling location. Locate the center point of the right side subframe bushing bolt, use a straight edge to draw a horizontal line for 19 mm inboard. From the end of the 19 mm horizontal line, use a straight edge to draw a vertical line for 294 mm. From the end of the 294 mm vertical line, mark this location as the center point for drilling. Drill this location using the 40 mm hole-saw. (Drill Speed Recommendation: 380 ~ 470 rpm).

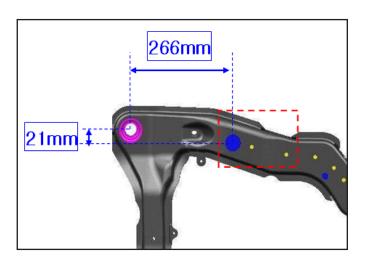
7b.In preparation for drilling the 40 mm hole-saw site four (4) in the left front, the following method must be used to insure proper drilling location. Locate the center point of the left side subframe bushing bolt, use a straight edge to draw a horizontal line for 21 mm inboard. From the end of the 21 mm horizontal line, use a straight edge to draw a vertical line for 266 mm. From the end of the 266 mm vertical line, mark this location as the center point for drilling. Drill this location using the 40 mm hole-saw. (Drill Speed Recommendation: 380 ~ 470 rpm).

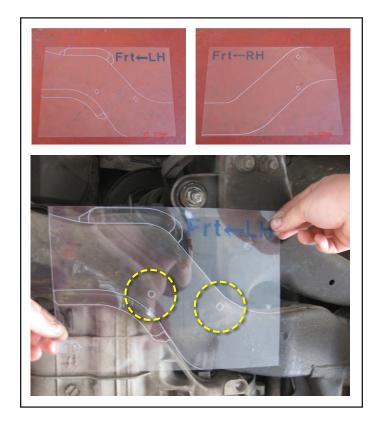
8. Place the LH and RH templates against the underside of the subframe, just parallel to the control arm with the arrows pointing forward. Align the outlines on the templates to the outboard shape of the subframe. Ensure proper orientation of the front (Frt) alignment of the templates for left/right. Use a grease pen to mark through the two holes on each template.

These holes will prevent any water which enters the subframe from becoming trapped.

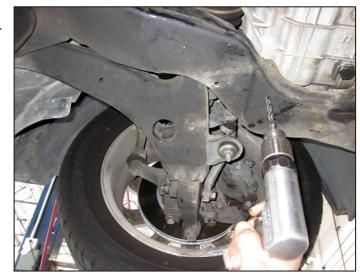
9. Using an 8mm drill, drill four (4) holes in the locations marked in the previous step. Debur all 8mm holes

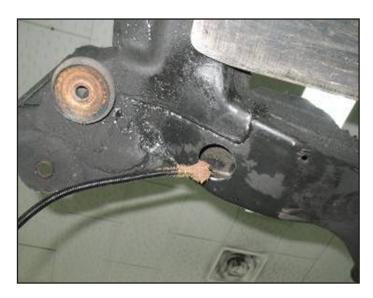
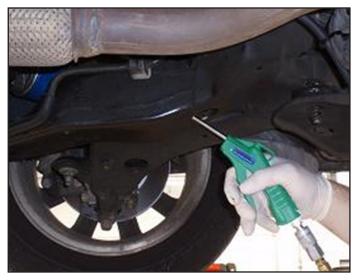
- 10. Use the following procedures to remove as much of the rust fragments as possible from inside the subframe.
 - a) Strike the underside of the subframe lightly with a hammer to cause vibration and dislodge any rust scale.

- b) Insert the magnetic pick up tool through each of the four 40mm holes and pull the magnet along in either direction as far as possible to remove any larger fragments.
- c) Insert air blow gun into each of the four 40mm & 8mm holes. Use shop air to blow as much of the rust particles as possible from inside the subframe. In some cases, if there is a large amount of loose rust scale present you may have to repeat the above steps another 2 to 3 times.

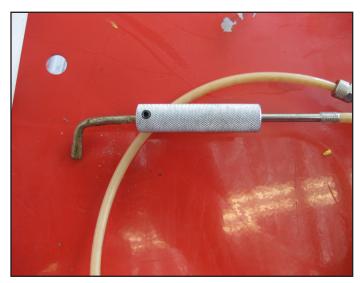
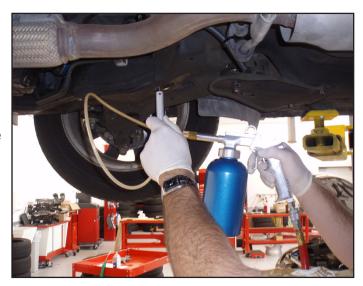
11. Pour one bottle of VG-101 Rust Preventive (Cavity Wax) into the wax injection container and connect the 90 degree nozzle assembly (shown). Spray the cavity wax into each of the four 40mm & 8mm holes and in all directions, dividing wax equally through each of 8 (eight) openings, using the entire bottle of cavity wax. You should begin to see some of the cavity wax draining from the four drain holes and other open areas of the subframe.

Make sure to use the entire bottle and attempt to coat as much of the inner surface area of the crossmember as possible.

After completing the cavity wax application, continue to blow shop air through the nozzle for a short time to clear any material from the nozzle.

Use a shop towel to clean any excess wax that has been sprayed onto the exterior portion of the subframe or is dripping from the drain holes.

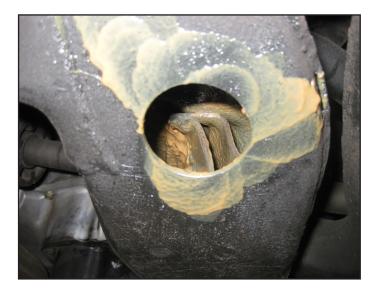
12. Spray undercoating on the underside of the subframe near the four (4) 40 mm access holes and 8 mm drain holes. Do not spray the entire subframe with undercoating.

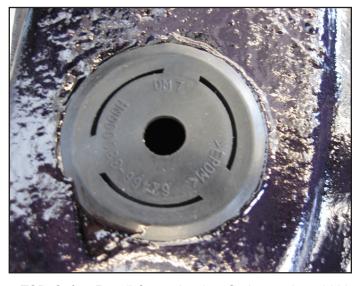
13. Cover all four (4) of the 40mm access holes with the hole plugs listed in the parts information section and apply a small amount of undercoating across the plugs.

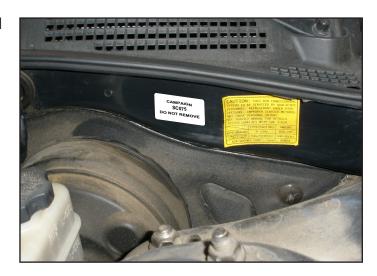
14. Lower the vehicle, open the hood and install the SC075 completion label on the panel above the the master cylinder.
